## **Stray Current Corrosion Risks and Case Histories in Communication Tower and Electric Transmission Applications**

Anil Kumar Chikkam, Freddy Avendano and Peyman Taheri  
Matergenics, Inc.  
100 Business Center Drive  
Pittsburgh, PA 15205

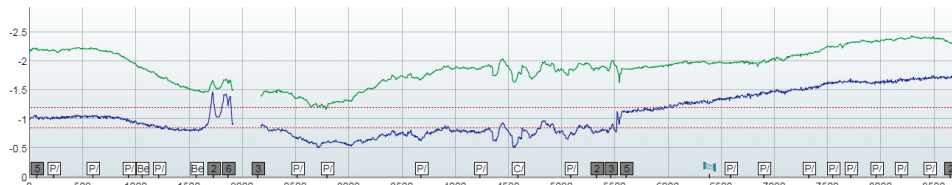
**Figure 1A: CIP Survey Graph (Pipe-to-soil,  $V_{CSE}$  vs. Length [ft]) – Target Line ICCP Systems Interrupting.**

As shown in Figure 1A, the target ICCP system Off potentials (denoted by the blue line) are more electropositive than  $-0.850 V_{CSE}$ . Foreign pipelines cross the target pipeline near footage mark 1,750. The operator suspected stray current.

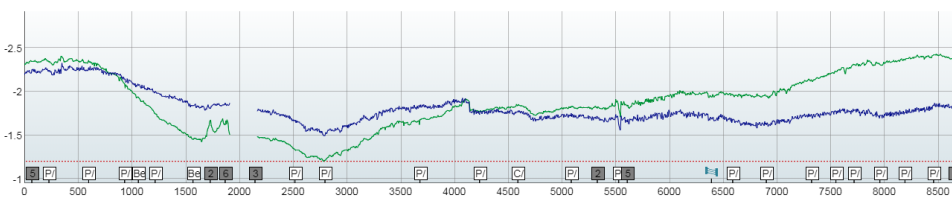
**Figure 1B: CIP Survey Graph (Pipe-to-soil,  $V_{CSE}$  vs. Length [ft]) – Foreign Line ICCP Systems Interrupting.**

Figure 1B shows an area where the foreign rectifier On potentials (denoted by the red line) are more electronegative than the Off potentials (denoted by the blue line). The inverted potentials denote the area of detrimental influence.

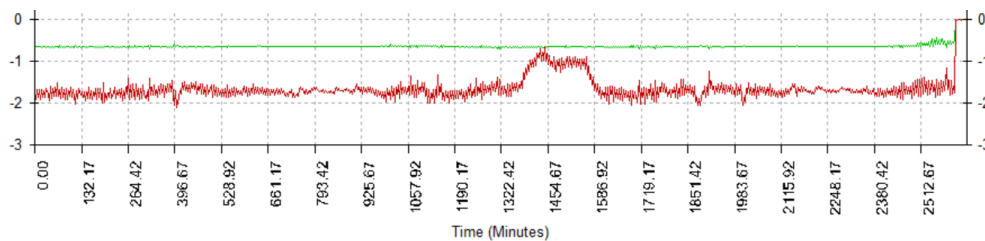
Dynamic stray currents are more difficult to detect as they may not be present during periodic testing, and therefore may not be detected. When dynamic stray currents are typically evaluated using continuous data logging of structure-to-soil potentials over an extended period. Figure 2 shows an example dynamic stray current monitoring. The three-hour electropositive shift shown in the graph was caused by a dynamic stray current source.

**Figure 2: Dynamic Stray Current Monitoring on Pipeline.**

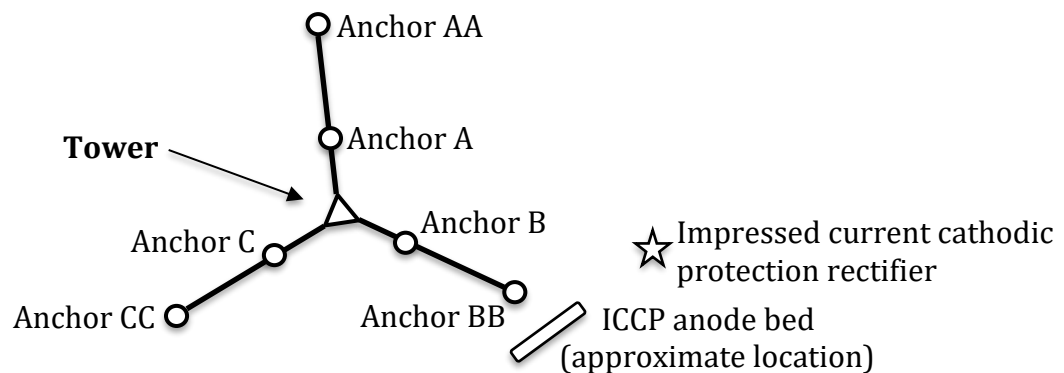
**Figure 4: Diagram of guyed telecommunication tower, guy anchors, and nearby impressed current cathodic protection system. Drawing approximately to scale with ~300 feet between the tower and outer anchors.**

The difference in potentials between anchors prompted a search for sources of stray current. A quick survey of the surrounding area revealed an impressed current cathodic protection rectifier. The owner of the rectifier revealed the approximate location of the shallow anode bed associated with the rectifier. The anode bed was near anchor BB. This was consistent with the high electronegative potentials measured on anchor BB.

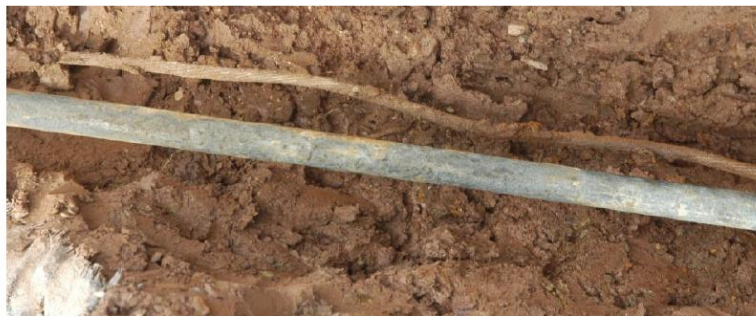
Confirmatory excavations were performed on anchors B and AA. Anchor CC was suspected of having the worst corrosion damage based on the potential measurements, however, anchor AA was excavated first because of site access issues. Anchor B exhibited loss of galvanizing and minor corrosion of the steel substrate as shown in Figure 5. These findings were consistent with the anchor-to-soil potentials which are in a normal range for steel in soil.

**Figure 5: Single round shaft of anchor B. Galvanizing loss and minor surface corrosion below ground.**

All anchors were excavated and replaced with concrete-encased anchors. Recommendations were made for stray current mitigation, including installation of magnesium anodes at the anchors affected by stray current corrosion because stray current affect concrete-encased steel as well as buried steel.

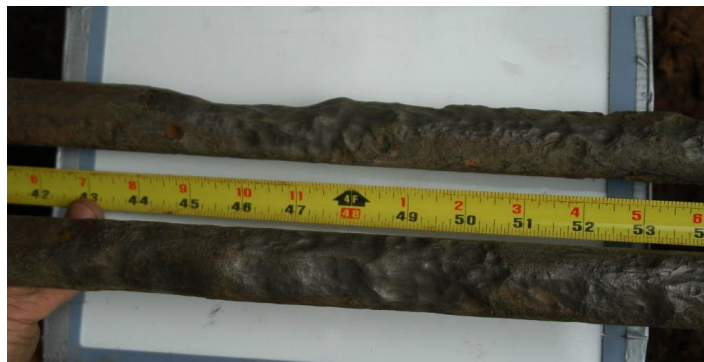
Anchor AA exhibited 60% cross-sectional corrosion loss on one of the two anchor shafts as shown in Figure 6. This finding was also consistent with the electropositive potentials measured at this anchor. Recommendations were made for temporary securement and excavation of the remaining anchors.

**Figure 6: Dual round shafts of anchor AA. Maximum cross-sectional loss of 60% was measured on one of the two anchor shafts. Both shafts exhibited severe corrosion damage.**

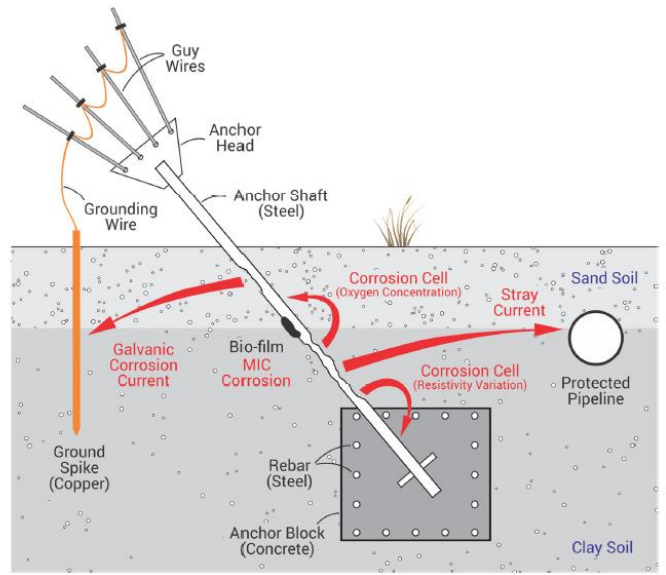
**Figure 9: Different forms of corrosion at anchor shafts.**

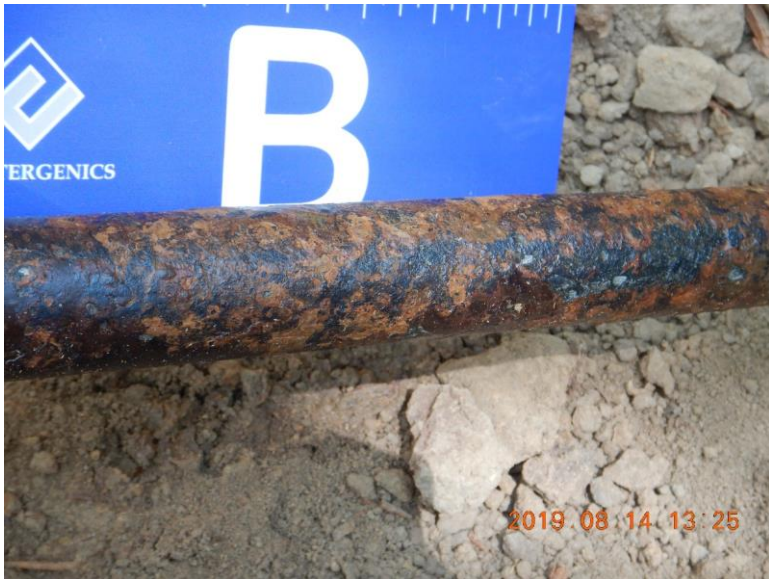
After digging, visual examination was performed on the buried guyed anchors up to 3 feet below ground level. Visual examination has revealed that anchor A is not corroded. However, visual examination of anchors B and C revealed that galvanized layer is almost consumed, and corrosion was observed on the anchors (Figures 10 and 11). Shallow pitting was observed on anchors B and C. Corrosion increased with the increase in the depth from the ground level.

**Figure 10: Photograph showing corroded anchor B.**

Galvanic cathodic protection (CP) systems with 17 pound high-potential magnesium anodes are designed, installed, and tested at anchor footings of the tower. According to the NACE SP0169-2013,<sup>4</sup> to assess the performance of cathodic protection systems the following criteria was used:

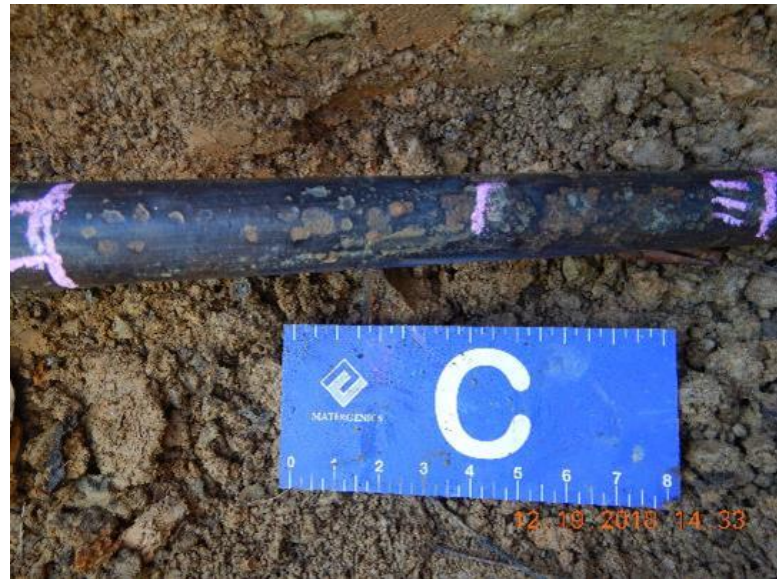
**Figure 11: Photograph showing corroded anchor C.**

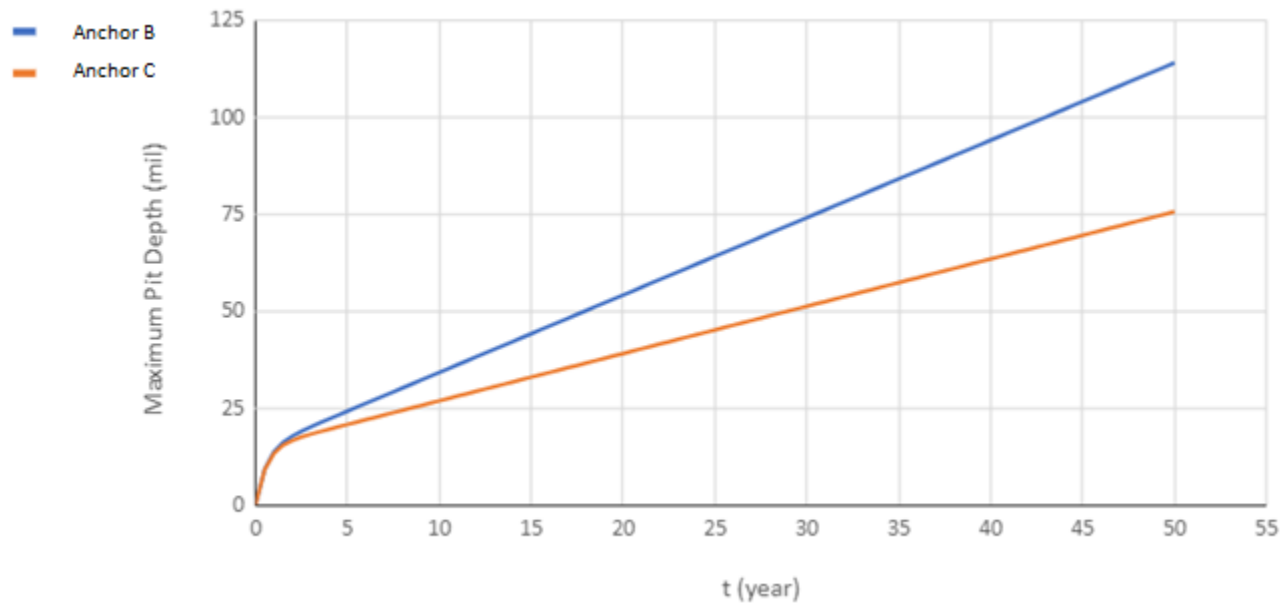
Corrosion rate prediction of anchors B and C inspected at this site is shown in Figure 12. At the beginning, the corrosion rate is high because of the absence of a protective layer on the surface, however, the corrosion rate decreases after a few years as a protective oxide layer forms on the surface and stabilizes. This in-situ formed layer will provide a barrier against diffusion of oxygen and moisture moving towards the fresh steel surface.

**Figure 12: Plot showing corrosion rate prediction of anchors B and C.**

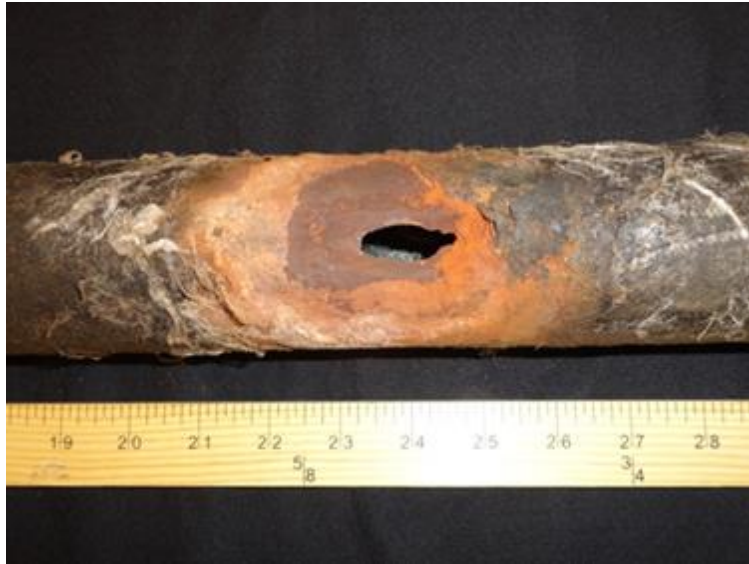
Figure 13 shows the as-received perforated pipe. Delaminated polypropylene jacketed coating is shown in Figure 14. The corrosion attack of the pipe is highly localized. No other part of the pipe exhibited this extent of corrosion attack. The laboratory investigation also included Fourier transformer infrared (FTIR) analysis, scanning electron

Figure 13: Photograph showing as-received perforated pipe sample.

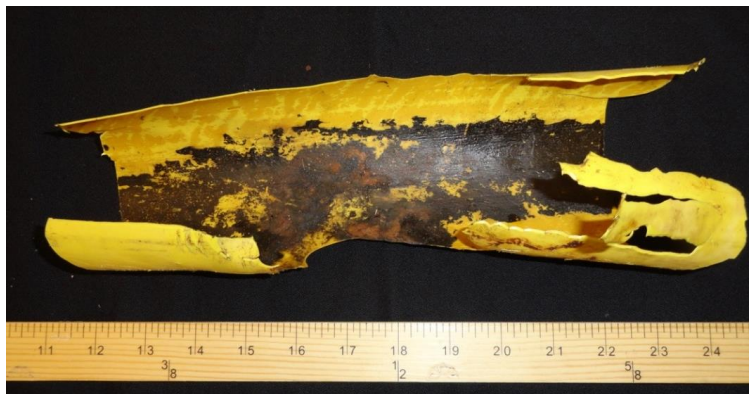
Figure 14: Photograph of the plastic extruded coating separated from the pipe.

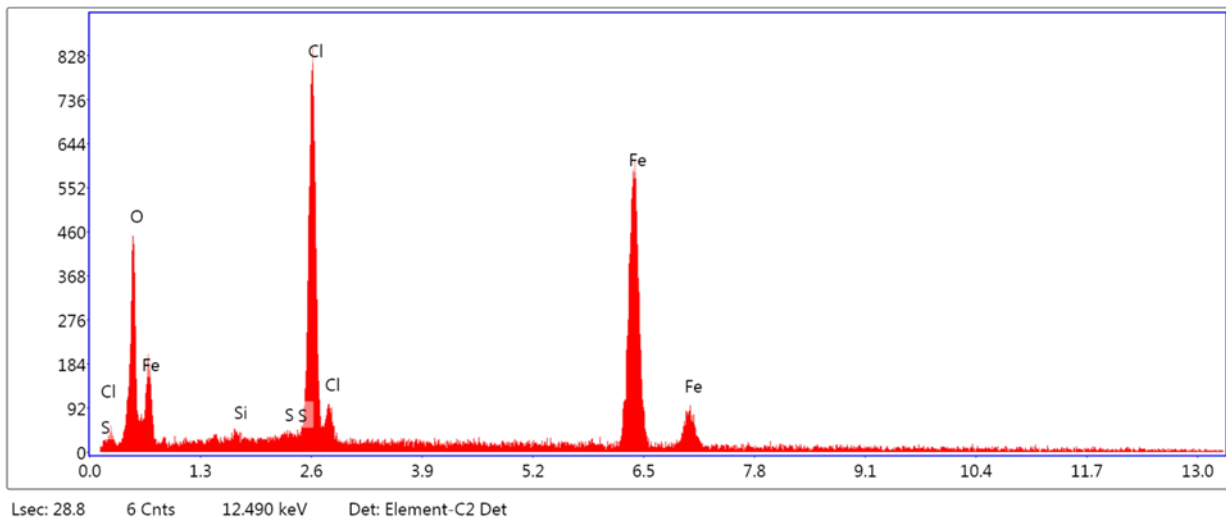
Figure 15: SEM/EDS analysis showing extremely high concentrations of chloride containing compounds in corrosion products.

EDS analysis is used to perform elemental analysis of the corrosion products. Using this analytical technique the corrosion product samples taken from the perforated area of the pipe were examined. Extremely high concentrations of chloride containing compounds were detected in corrosion products (Figure 15).
